STABILITY CERTIFICATE

Name of work: Kusr Gram panchayat Water tank

Year of construction: 1992/93

Date of Audit: 11/02/2023

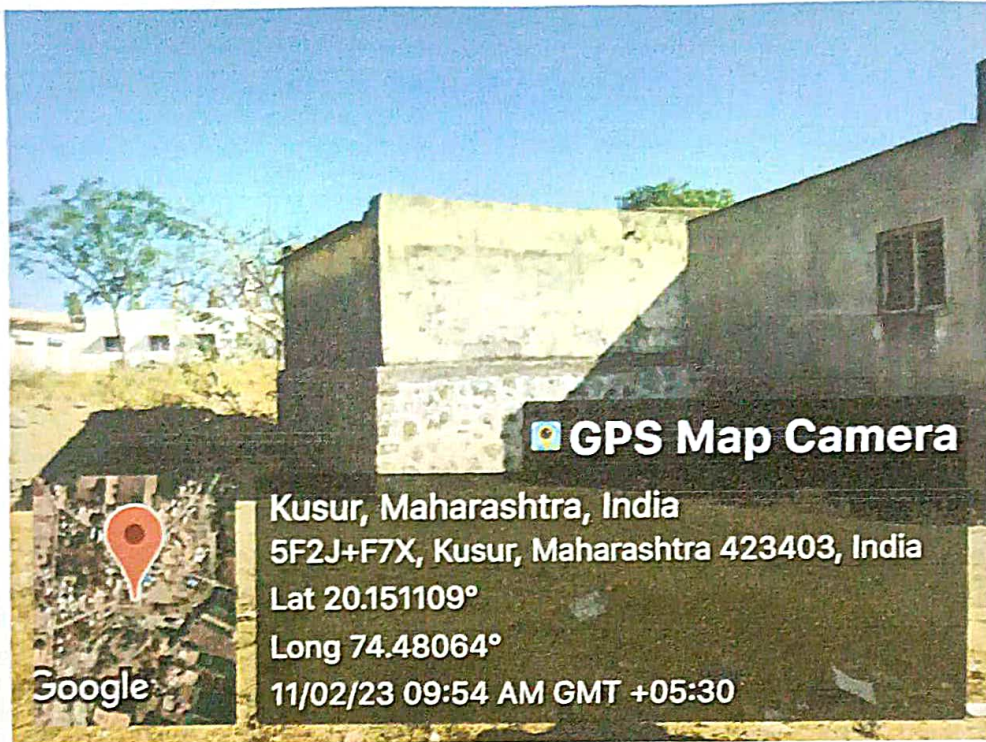
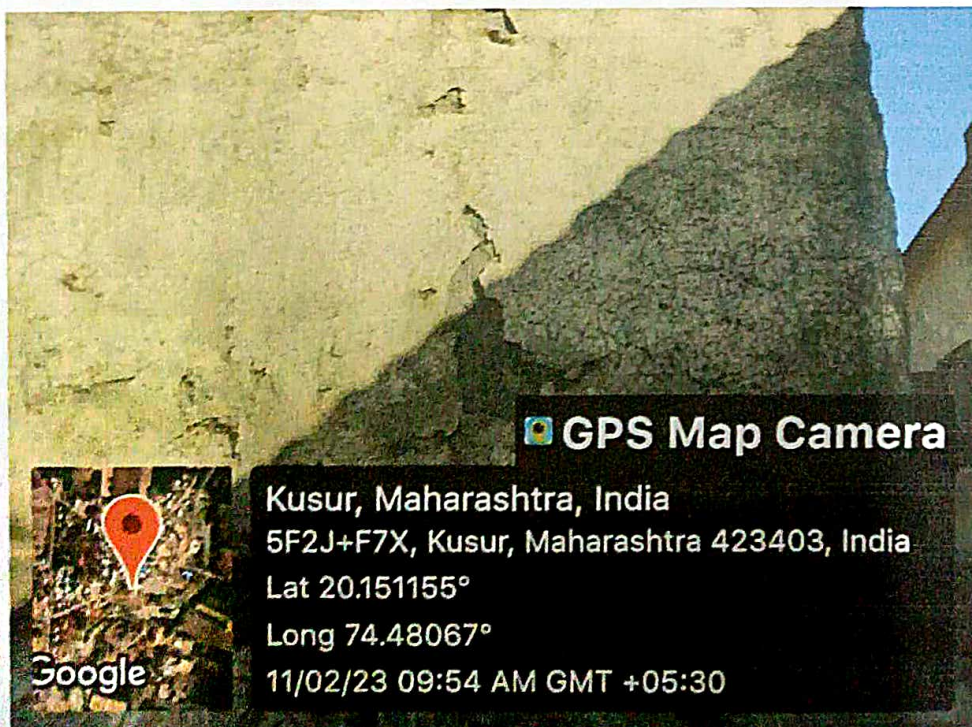
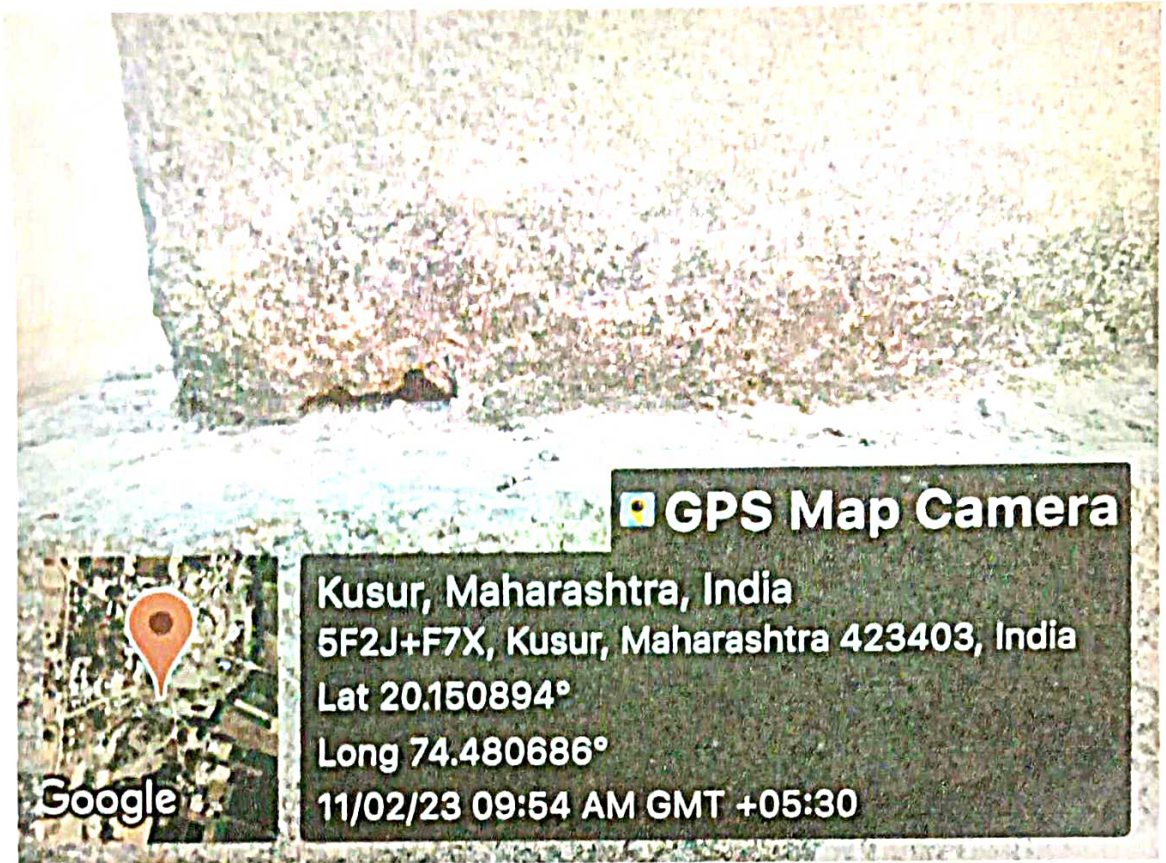
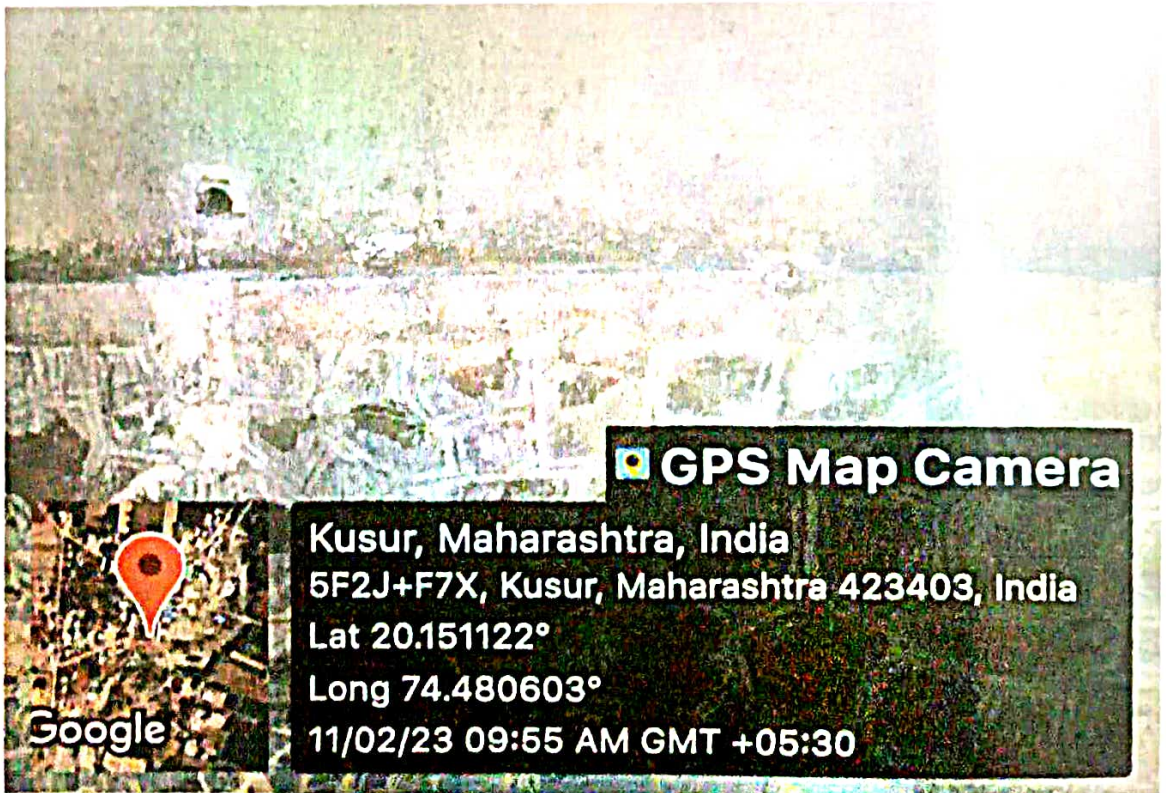
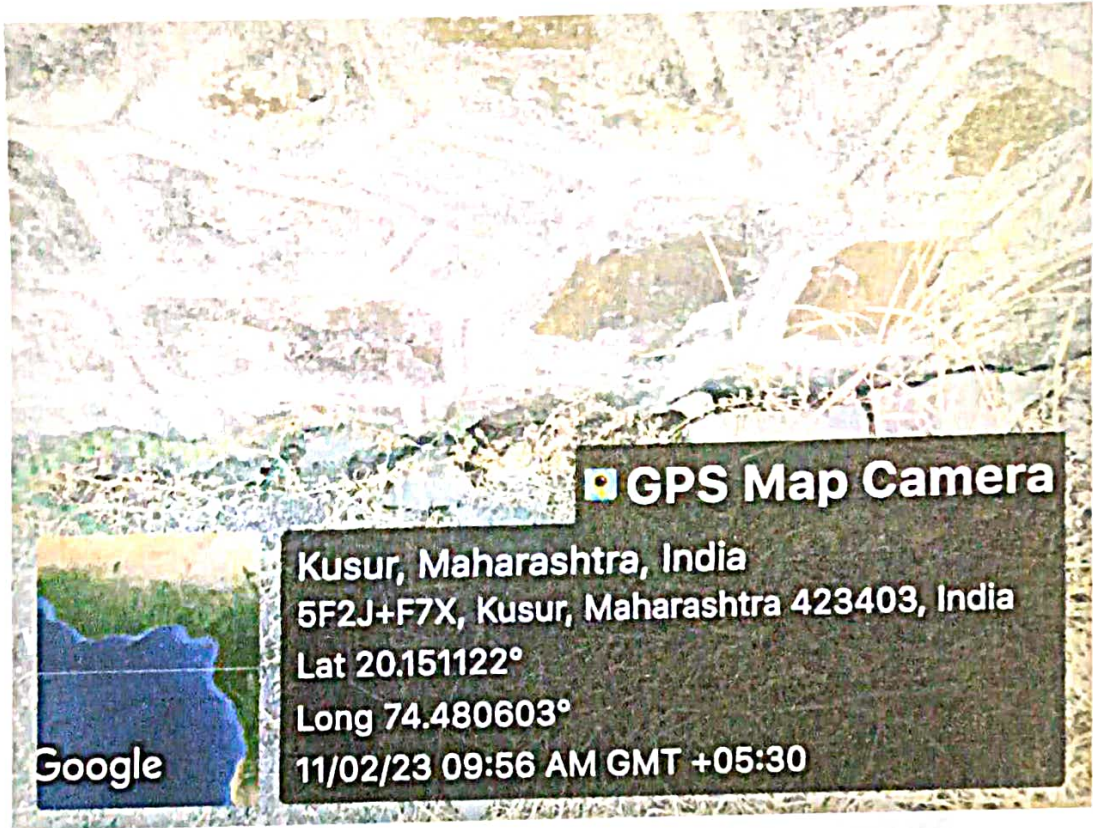
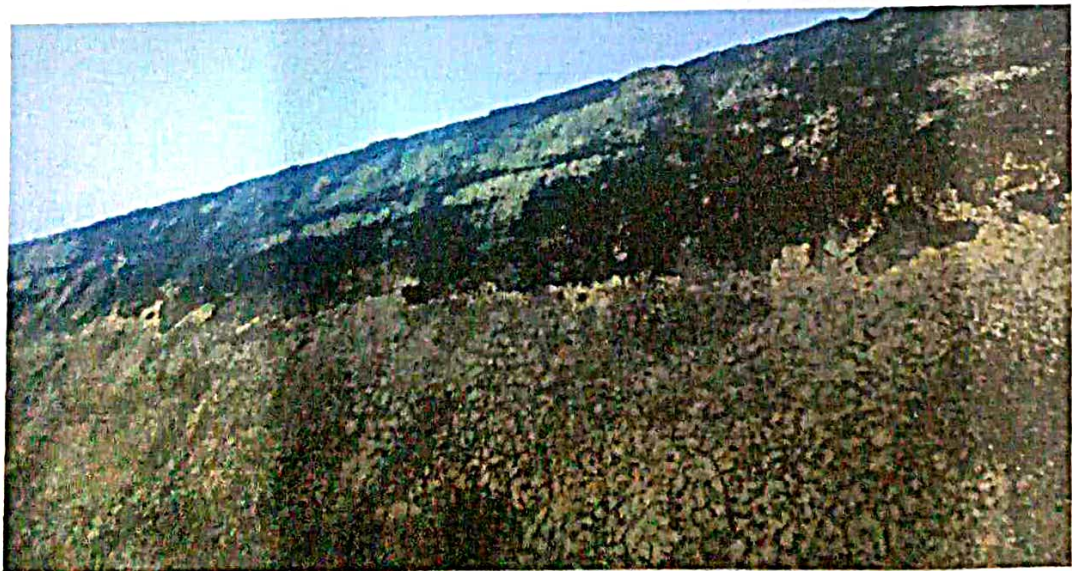
We find out the water storage capacity of water tank is reduced due to fault in water tank structure and its life span. It is found that the water tank is not in use since 2007 due to leakage through masonry wall. So, the purpose for which it is constructed is not satisfying. The water tank is not properly maintained considering its lifespan till date. Cracks & Deterioration of masonry wall was found. We have visually inspected masonry wall, rubble masonry and roof top & found that they do not meet all the standards concerning to the strength parameters. We also observed that all the members are unsound, not-safe & unstable & hence repair works will not work in structural point of view. Hence Suggested to demolish.

Most of wall area was in deteriorated condition, While the water tanks have major concerns pertaining to the structural stability of the water tank, since the cracks that have appeared on the floor seems to be major cracks, owing to the appearance of the nature of the cracks width and the condition of the soffit of the roof area, when viewed from the basement. Hence remedial measures would not work and it would be better to demolish.

Sr. No.	Description	Condition		Remark
		Yes	No	
1.	Critical section	✓		
2.	Formation in portal frame			NA
3.	Failure of steel section			NA
4.	Failure in bolted section			NA
5.	Defects in welded joint			NA
6.	Corroded steel sections			NA
7.	Crack on floor	✓		
8.	Severe Leakage found if any	✓		
9.	Deteriorated Rubble masonry	✓		
10.	Corrosion in GI sheet and roof	✓
